Ductile Iron Piles Corrosion Resistance

DUROTERRA

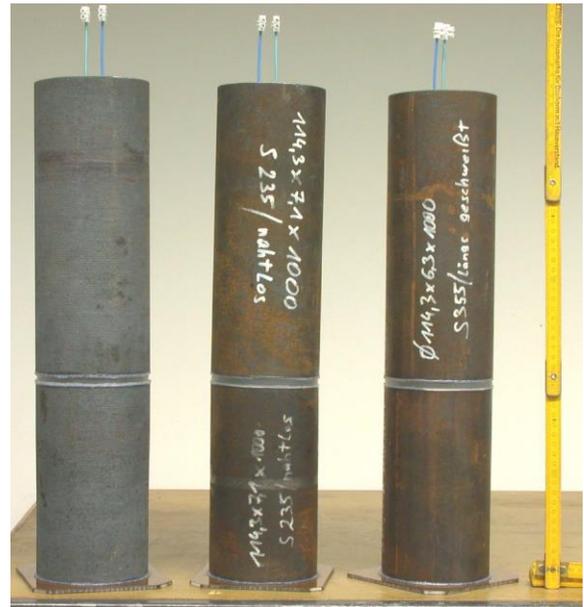
Figure 1: Picture of Samples prior to Testing

Similar dimensioned samples of Ductile Iron Pile, and European S235 steel (ASTM A284 equivalent) and European S355 (ASTM A633, A656 equivalent) were selected (Figure 1). The samples were placed into a controlled environment consisting of compact sand in the lower portion and gravel in the upper portion as shown in Figures 2 and 3. The container was filled with an electrolyte (deionized water and dissolved salts). The electrolyte was routinely flushed with aerated water, but only in the upper portion to increase oxygen exposure. The compact sand environment models a stagnant, low oxygen environment while the gravel (upper) environment models a high-oxygen condition with routine flushes of the electrolyte. As a result of the test setup, the aerated (upper) section models an oxygen reduction reaction while the non-aerated (lower) section models anodic metal dissolution.

Figure 4 shows a picture of the prepared samples prior to introduction to the test device: Ductile Iron Pile, S235 steel, S355 steel (left to right). Figure 5 shows a picture of the samples following removal from the test environment.

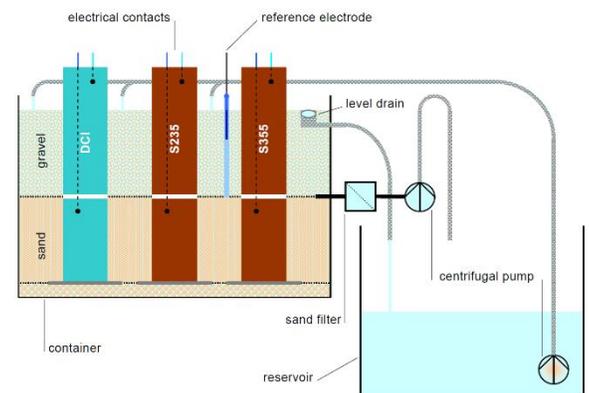
Figure 2: Schematic of Test Setup

The test setup included instrumentation including shunt resistors, a reference electrode and a data acquisition system to record the corrosion current between the sections and the corrosion potential. Tests were performed continually over the course of 441 days to evaluate the effects on the samples.

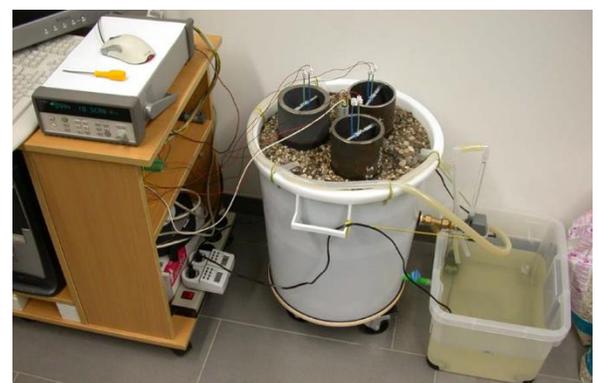
Figure 3: Picture of Lab Test Setup

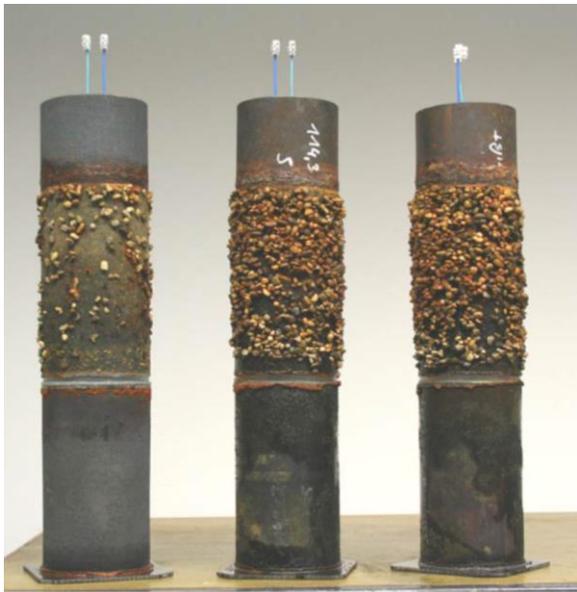
Figure 4: Picture of Samples after Testing (pre-cleaning)

the pile surface and the pebble were few. The behavior in the lower anaerobic portion of the setup was dictated by anodic reaction created by the electrical contact with the cathodic upper portion. This anodic reaction caused metal dissolution at localized areas thereby reducing the effectiveness of the corrosion passivation. However, this behavior resulted in only shallow, localized pitting of the skin.

In contrast, the steel samples behave as an actively corroding metal. The rolling skin from the manufacturing process offered far less protection than the Ductile Iron casting skin, resulting in a more wide-spread pattern of corrosion evidenced by the nearly complete coverage of pebbles to corrosion locations (Figure 5). The development of this corrosion layer does have a benefit by acting to reduce the access to oxygen and reduce continued corrosion with time only after substantial corrosion has occurred. The presence of the electrical current created by coupling with the upper section intensified the corrosion and the dissolution of the rolling skin in the lower portion.

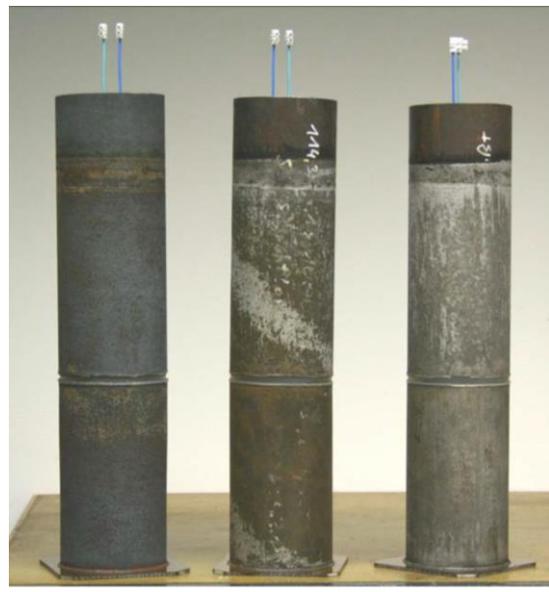
Figure 5: Picture of Samples after Testing (post-cleaning)

In summary, the Ductile Iron Pile exhibits superior corrosion protection. The ductile pile material performed better than steel in the simulated corrosive environment with only localized areas of corrosion product and shallow pitting – a vast difference compared to the overall performance of the steel sections.
